DOVER LAKE DAM

GOOCHLAND COUNTY, VIRGINIA

VA. NO. 07503

# PHASE I INSPECTION REPORT

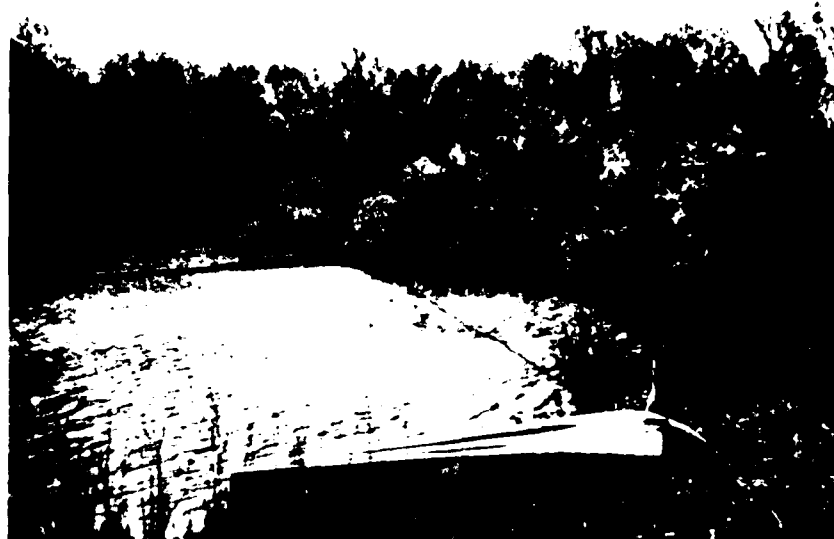
No sloughing or erosion was noted on the downstream slope; however, numerous erosional notches occur between the trees along the entire upstream slope at pool level. These notches extend approximately 3 ft into the embankment and range from 1 to 10 ft in width. Several groundhog holes were observed along the bottom 10 ft of the downstream slope, approximately 90 ft from the left abutment. Some erosion or washing consisting of a flow path 1 to 2 ft deep and 1 ft wide was noted in the discharge section of the right emergency spillway. Some erosion was also noted on the right spillway side slope.

Photograph No. 1 - Upstream Face of Dam  
(Arrow Indicates Intake Pipes)

Considerable erosion was noted on the embankment along the upstream slope due to wave activity. It is recommended this erosion be corrected and that riprap be placed along the upstream slope to provide embankment protection. Riprap should also be placed in the plunge pool to prevent erosion. The groundhog holes do not presently create an unsafe condition; however, future borrowing could result in numerous voids in the embankment which could be potentially hazardous under certain conditions. It is recommended that existing burrows be backfilled. The eroded area observed in the discharge section of the right emergency spillway should be backfilled and reseeded. Erosion noted on the right side slope does not require any special attention.

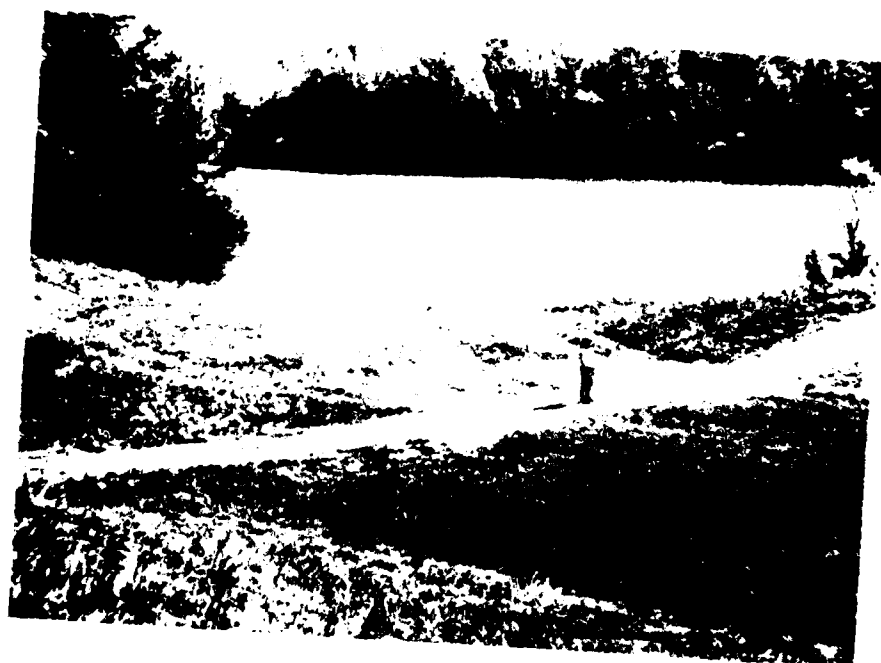
Photograph No. 4 - Emergency Spillway  
at Right Abutment

APPROACH CHANNEL	The approach channels were in good condition. They were grass covered with mild slopes of 1 to 2%.	
DISCHARGE CHANNEL	The left discharge channel was in good condition while some erosion was noted in the right discharge channel. Both were grass covered with moderate slopes of 5% <sub>+</sub>	See "Miscellaneous" comments below.
BRIDGE AND PIERS	None	
MISCELLANEOUS	Right emergency spillway was enlarged in 1980. Some erosion or washing was noted in the discharge section with the flow path 1 to 2 ft deep and 1 ft wide. The left side of the spillway is in fill, the right side in cut. Some erosion also noted along right side slope.	Eroded areas should be corrected and reseeded.

- f) The eroded area observed in the discharge section of the emergency spillway should be backfilled and reseeded.

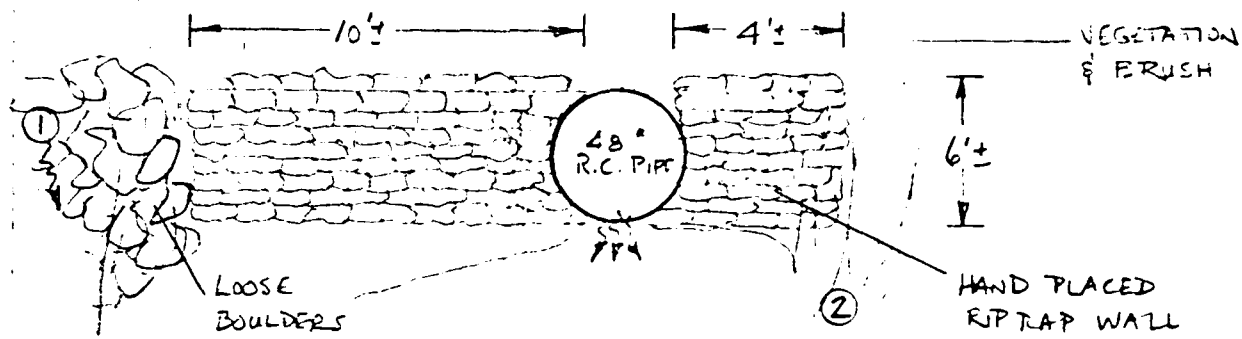
The only seepage encountered was in the vicinity of the discharge pipe. (See Field Sketch, Sheet 1, Appendix III). Iron stained seepage was observed flowing at an estimated 2-3 gpm from the base of a rock pile 12 to 14 ft downstream of the right end of pipe. No turbidity was noted. Iron staining was also encountered two locations below the left side of the pipe, 5 ft<sup>+</sup> and 50 ft<sup>+</sup> beyond the end of the pipe. No flow was observed at either location. The toe of the downstream slope was dry.

The seepage and iron staining observed downstream of the discharge pipe are believed to be related to seepage through the dam, but could possibly be related to spring activity. These areas do not present a hindrance to the normal functioning of the dam, however, it is recommended they be monitored quarterly to detect any increase in flow rates which may cause piping in the embankment. If increased flows should occur, a Professional Engineer with expertise in Geotechnical Engineering should be contacted to evaluate the problem and make recommendations for required corrective measures.

- ③
- ① IRON STAINED SEEPAGE FLOWING @ ESTIMATED 2-3 gpm FROM BASE OF ROCK, ABOUT SAME ELEVATION AS TOP OF DISCHARGE PIPE. LOCATED 12-14' FROM RIGHT END OF WALL. NO TURBIDITY WAS NOTED.
  - ② IRON STAINED SATURATED AREA LOCATED 5'± BEYOND DISCHARGE PIPE; NO FLOW OBSERVED.
  - ③ IRON STAINED SATURATED AREA LOCATED 50'± BEYOND DISCHARGE PIPE; NO FLOW OBSERVED.

- e) Seepage present below the discharge pipe should be monitored quarterly to detect any increase in flow rates which may cause piping within the embankment. If increased flows should occur, a Professional Engineer with expertise in Geotechnical Engineering should be contacted to evaluate the problem and make recommendations for required corrective measures.
